—FAITH MINE

RE:
Prior Reclamation Inspections

**PRIOR RECLAMATION INSPECTION REPORT
AND
RECOMMENDATION FOR RELEASE OR PERMIT
REQUIREMENT**

Santa Fe Pacific Gold Corporation

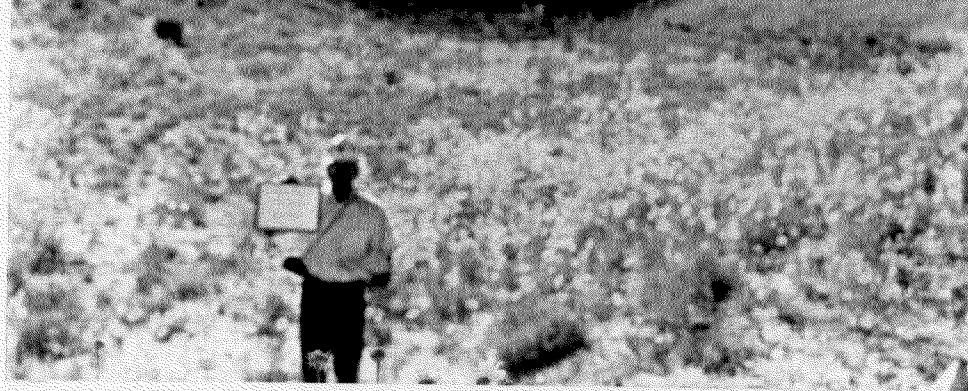
Poison Canyon Mine, Reclaimed Declined Shaft, 9/12/95

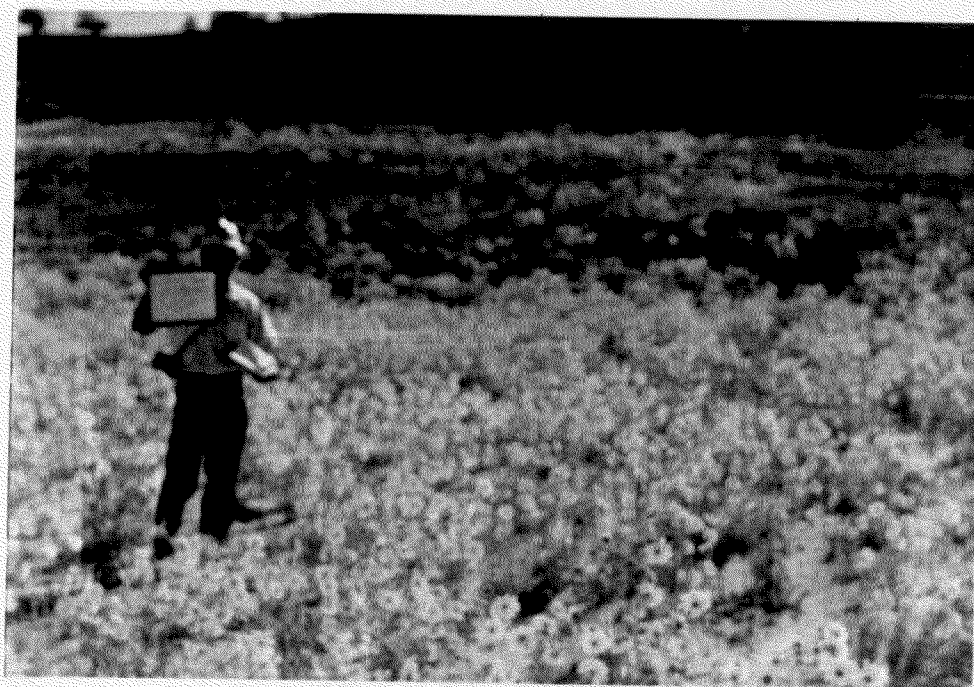
Poison Canyon Mine, Small Depression, 9/12/95

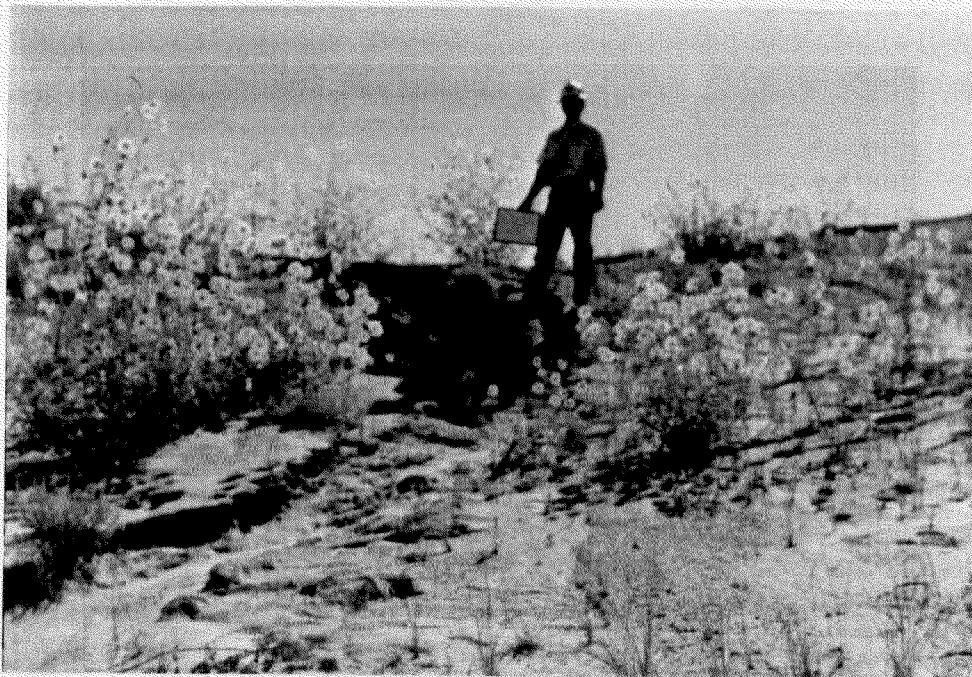
Poison Canyon Mine, Erosion Feature, 9/12/95
